SIXTH ENDORSEMENT on CO, VMF-451 ADDENDUM to AAR ser 3-58 concerning FJ-4
BUNO 139470 accident occurring 14 May 1958, Pilot PECK

Subj: Major Aircraft Accident Report, case of First Lieutenant Matthew
B. PECK Jr., (b) (6) /7332 USMC

AIRCRAFT ACCIDENT REPORT

OPNAV REPORT 3750-1

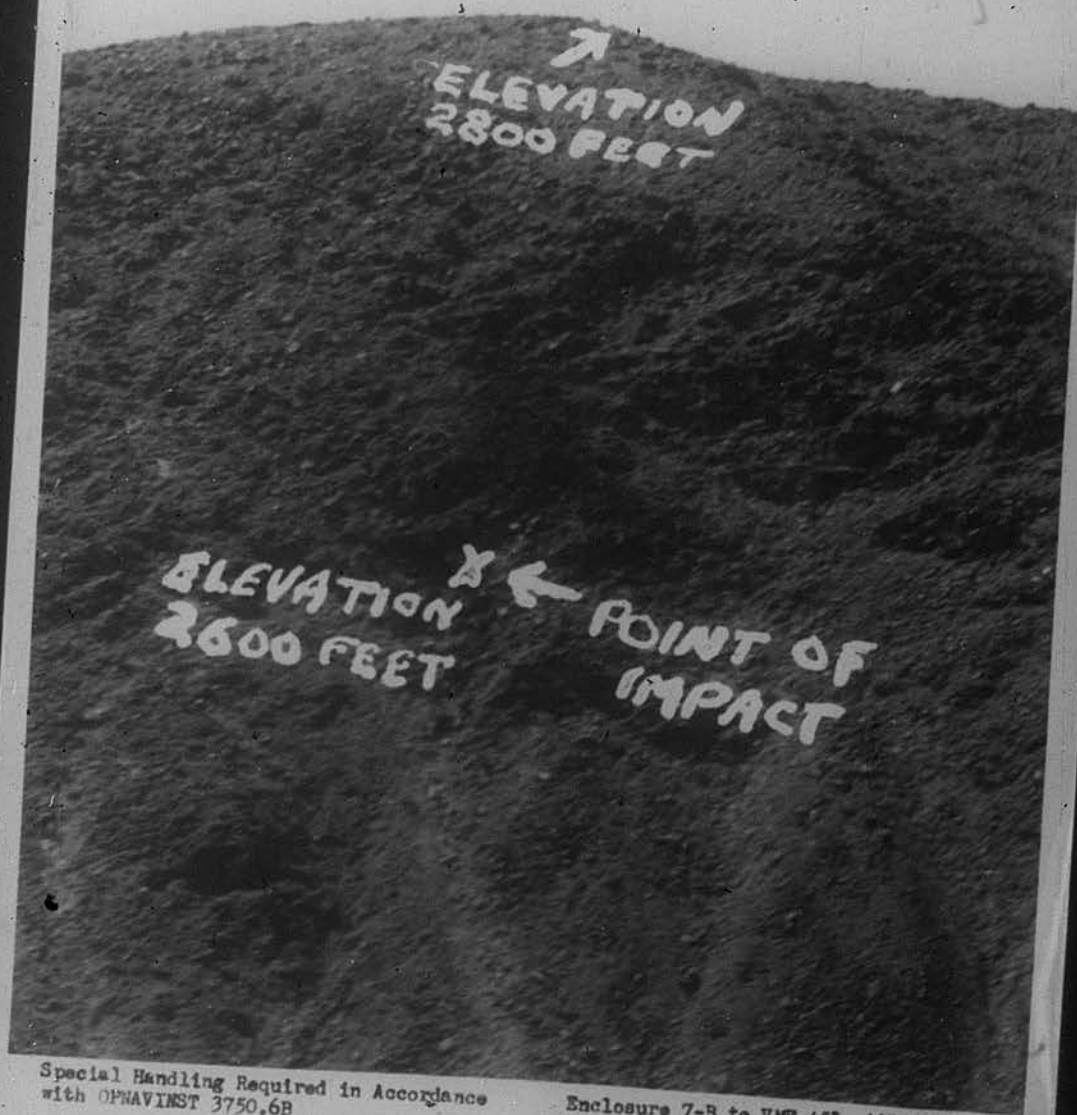
1. At approximately 0830, on 14 May 1958, First Lieutenant Matthew B. PECK Jr., 060288/7332 took off from MDAAS Mojave on a scheduled air-to-air missile firing hop. Lt. PECK was the designated leader of a flight consisting of three other squadron pilots and an inspector pilot. The flight took off and rendezvoused without incident and then proceeded to the Mojave "BRAVO" Range (restricted area 277) as briefed. (see enclosure 7A). At approximately 0845 Lt. PECK contacted China Lake tower and received clearance for his flight to enter the range. Shortly after entering the range, Lt. PECK instructed the flight to drop back as he previously had briefed. He then nosed up approximately thirty (30) degrees above the horizon, rolled inverted, and commenced an easy pull through intending to fire his target and sidewinder missile from this attitude. About ten (10) degrees above the horizon and at an altitude of approximately 33000 feet he fired his target rocket. The rocket ignited but remained on the rails and caused the aircraft to enter a violent yaw which was followed by an uncontrollable spinning maneuver. Unable to effect recovery, Lt. PECK successfully ejected at approximately 26000 feet. The aircraft crashed at 117° 9' west and 35° 45' north with an angle of impact of approximately seventy (70) degrees. (see enclosures (7A) and (7B)).

Enclosure 7-B to VMP-451, AAR 3-58
Showing Terrain in the Vicinity of
the Impact Area.

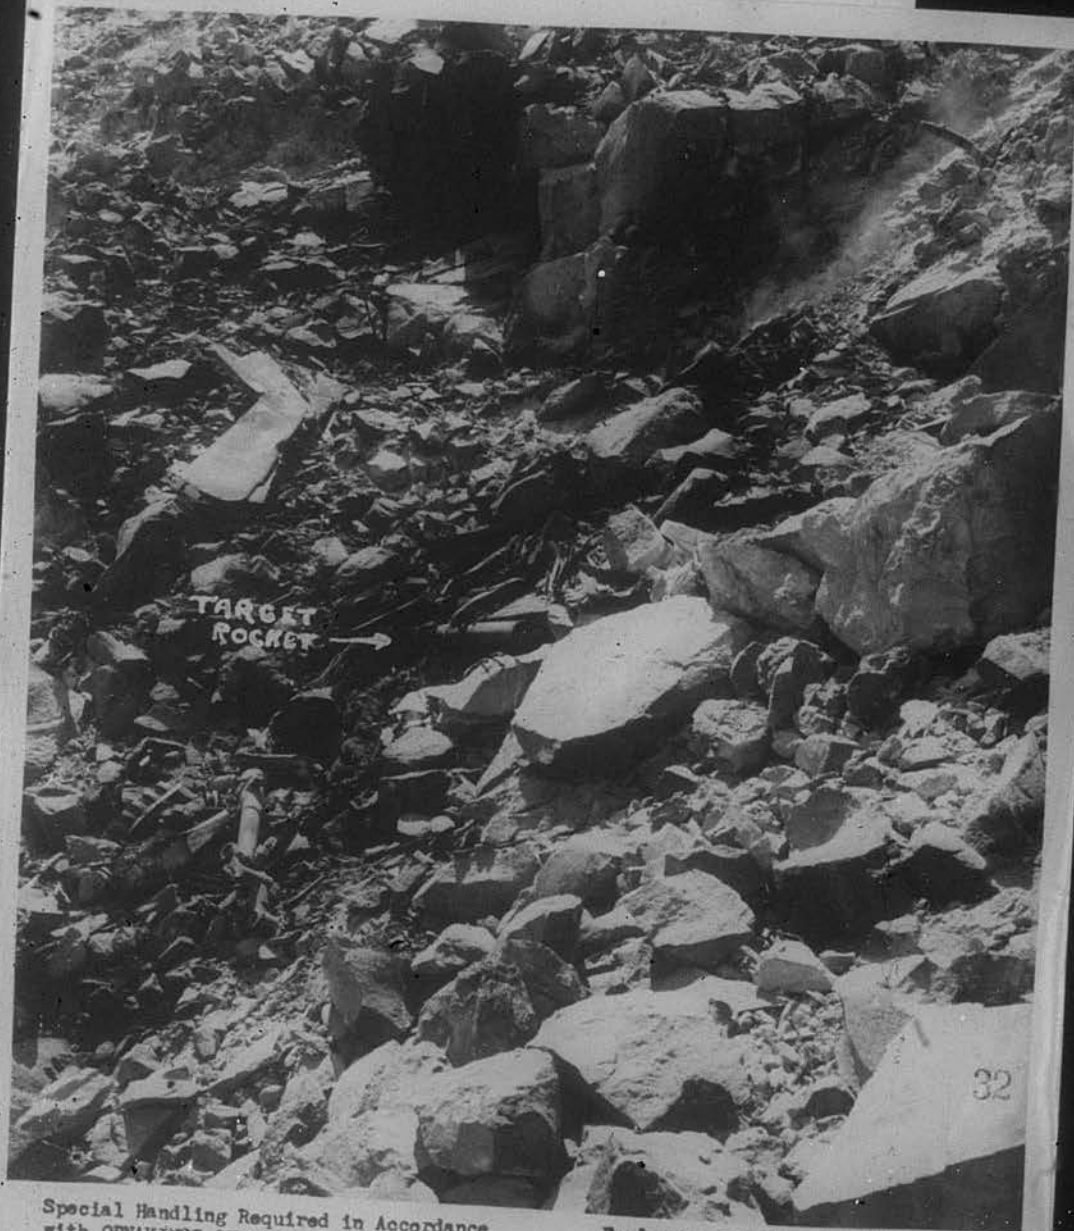
1. The aircraft contacted the ground with an angle of impact of approximately seventy (70) degrees and was completely demolished by the explosion and fire that followed. (see enclosures (7B) and (7C)). The beam adapter outboard (P/N 209-63012-1), Pylon Aero 3A (P/N LH-1440-511-92554558), Launcher Aero 3A (P/N 209-89 855), and the target Rocket, MK-10 motor, inert head were the only parts recovered. (see enclosures (7C), (7D) and (7E)).

Enclosure 7-C to VNF-451, AAR 3-58
Showing Impact Area and Target
Rocket as found.

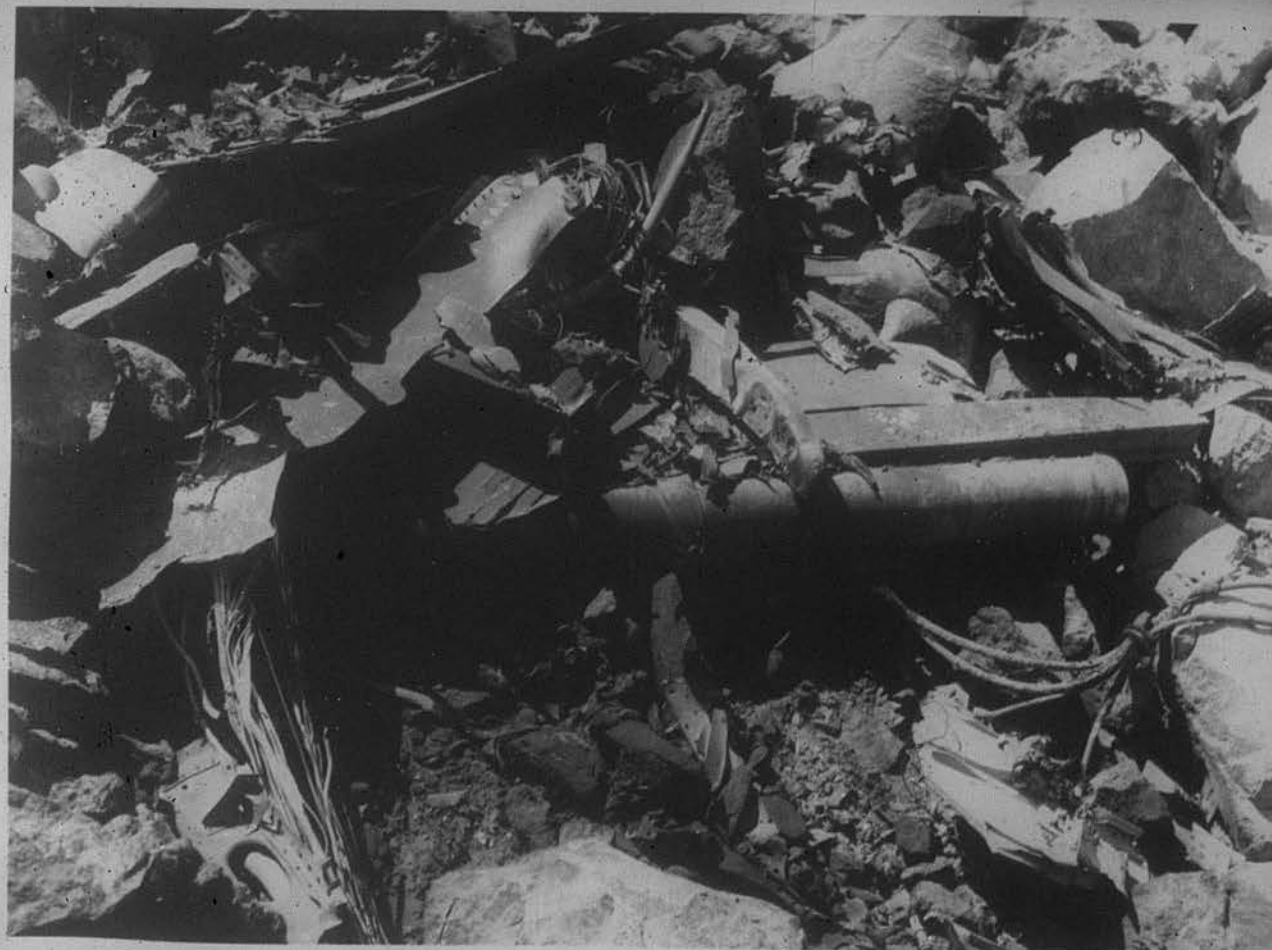
Enclosure 7-D to VMF-451, AAR 3-58.
Showing Target Rocket in its
Original Position Following Impact.

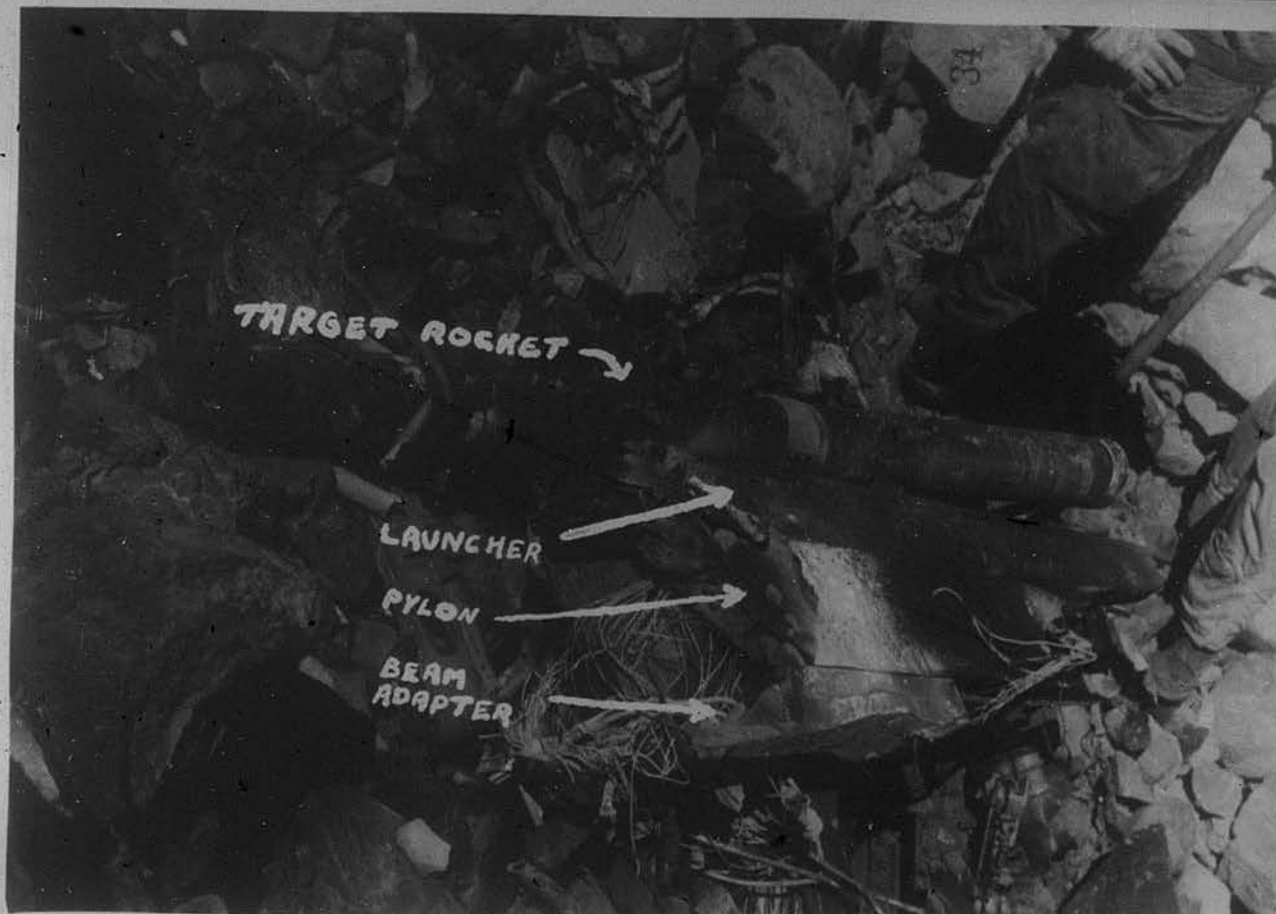
Enclosure 7-E to VMF-451, AAR 3-58.
Showing Target Rocket, Pylon, and
Launcher After it was Extricated
from Rubble at Impact Area.

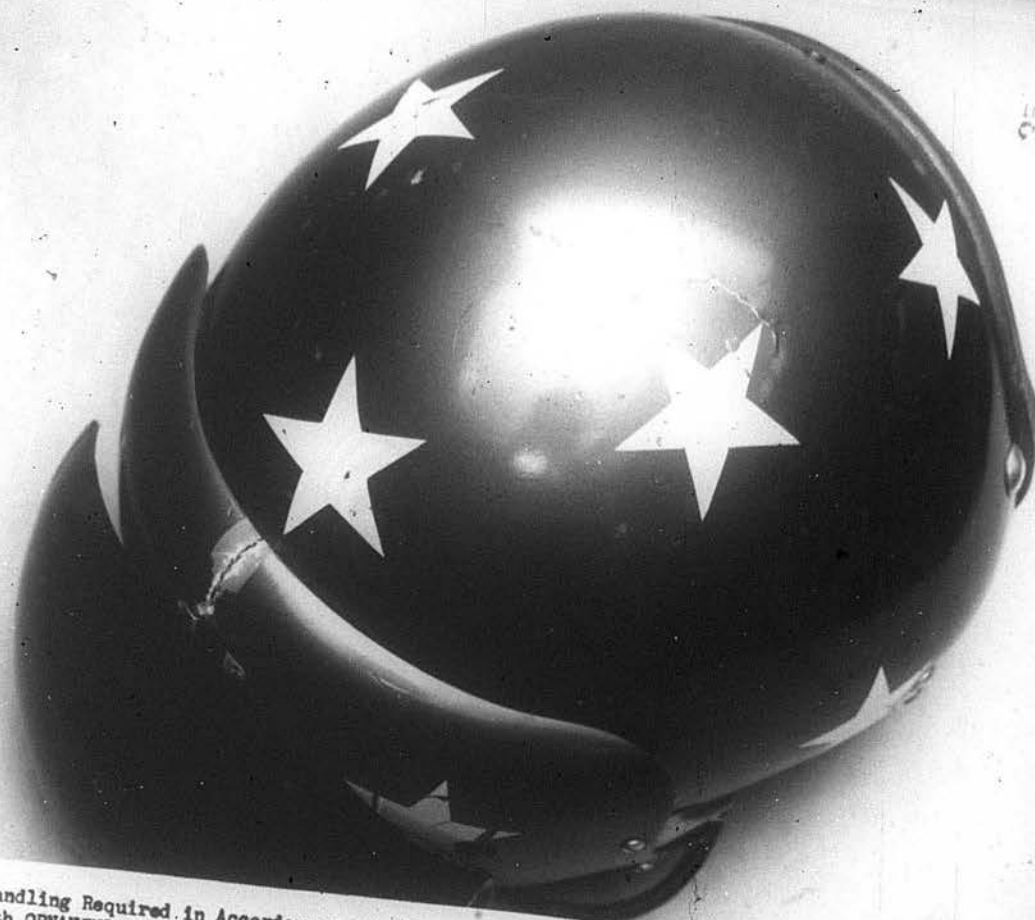
Enclosure 7-F to VMF-451, AAR 3-58.
Showing Damaged Helmet and Visor.
